LAKE SEBAGO DAM
ROCKLAND COUNTY
NEW YORK
INVENTORY NO 772

PHASE I INSPECTION REPORT
NATIONAL DAM SAFETY PROGRAM

National Dam Safety Program. Lake Sebago
Dam (772), Lower Hudson River Basin,
Rockland County, New York. Phase I
Inspection Report.

11 19 SEPTEMBER 1978

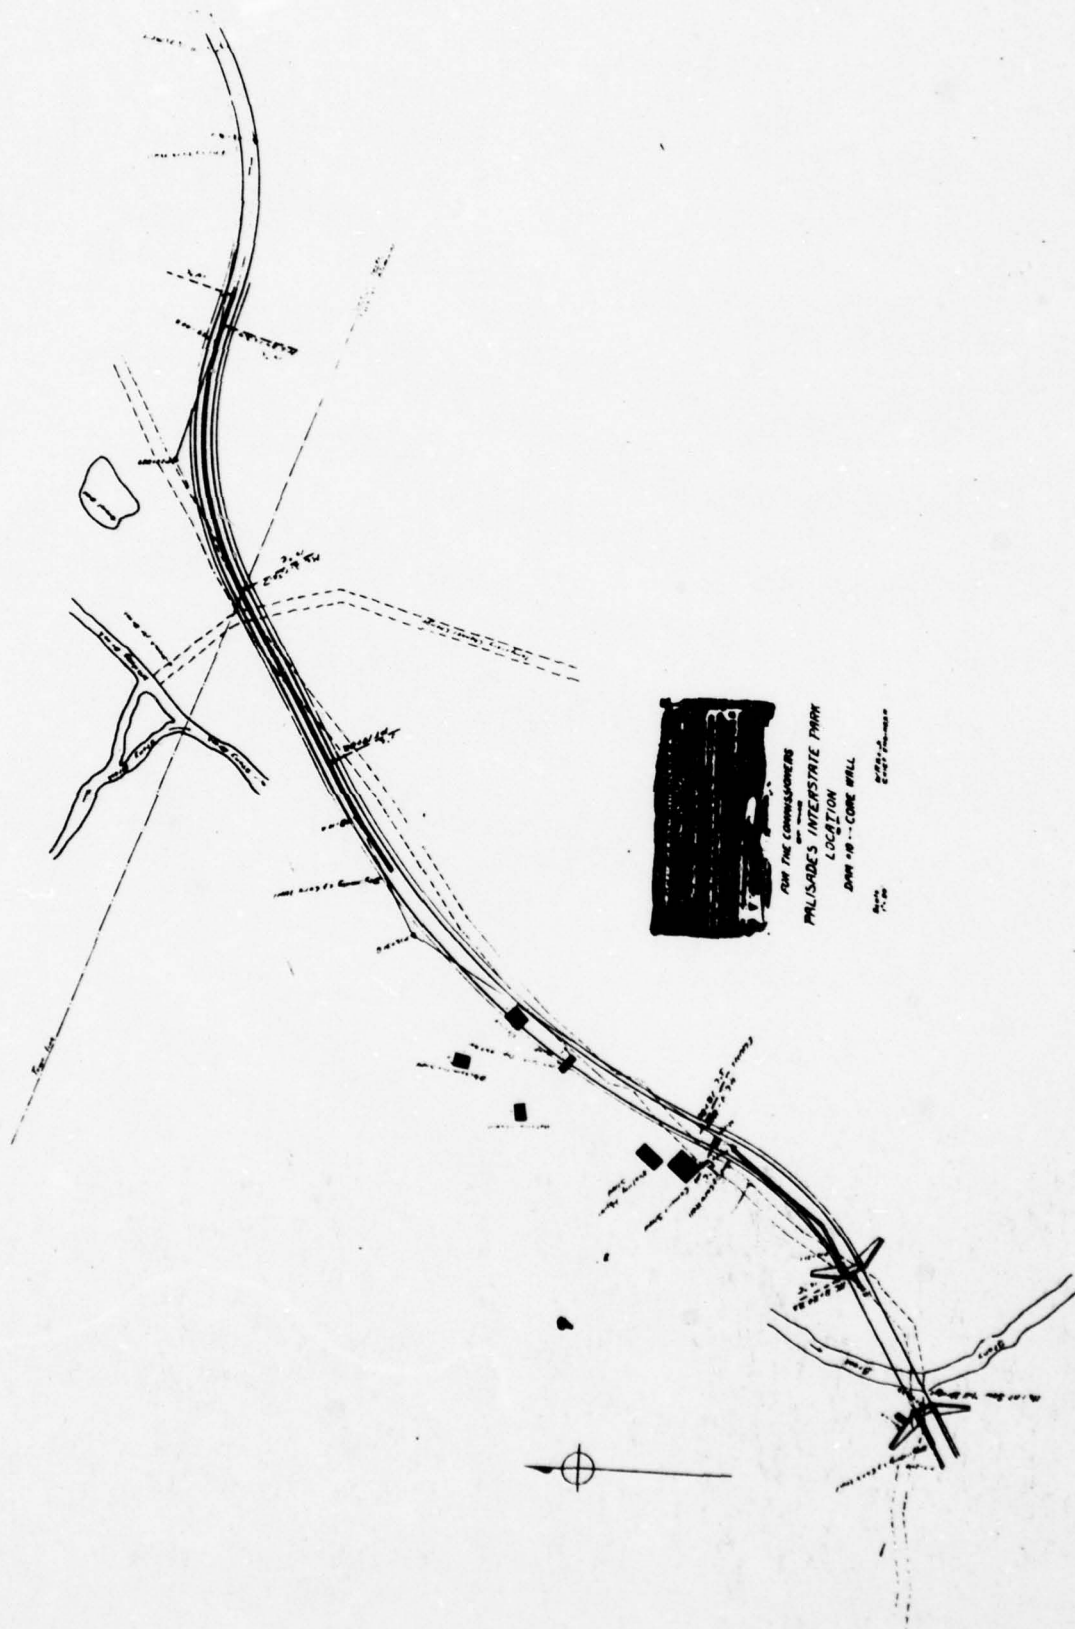
Figure 12

The gravity portion of the dam visually conforms to the plans. Limited information was available in the plans on the location of the 1500 feet of embankment with concrete core wall which is shown in Figure No. 12. The depth of the core wall is not known.

The embankment area, approximately 100 yards east of the dam at the old parkway area has considerable seepage midway down the embankment (Figure 12, Station PT 19 + 02). Large trees were growing on the upstream, downstream and on top of the dam. Seepage occurs along an embankment length a distance of over 100 feet. The flow is almost uniform across this area with considerable sheet flow at the downstream extremity. A large marsh exists in the depressed
